# Asbestos Management Survey with part Refurbishment/Demolition

Unit 1 Ground Floor

Wellington House

Pollard Street East

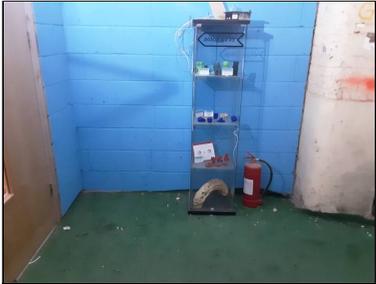
Survey Date:		Lead Surveyor		Survey Type		Floor		Analysis		
	26 Nov 2019 to 27 Nov 2019		Richard Watson		Management Survey with part Refurbishment/Demolition		Ground Floor		No asbestos detected		
	Building		Room		Item		Quantity				
	Main building		Entrance lobby G01		No suspect materials found		0				
	Sample No (S,SP,P,As)		Product Type		Surface Treatment		Condition		Accessibility		
	Visual (P)		N/A		N/A		N/A		N/A		
	Material Risk Score										
	N/A										
	Recommended action		No further action required								
	Surveyor comments		N/A

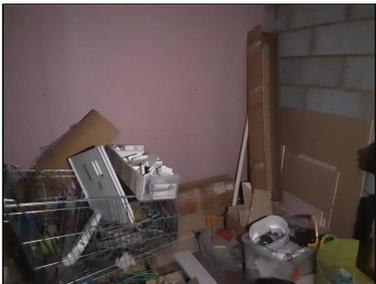
Survey Date:		Lead Surveyor		Survey Type		Floor		Analysis		
	26 Nov 2019 to 27 Nov 2019		Richard Watson		Management Survey with part Refurbishment/Demolition		Ground Floor		No asbestos detected		
	Building		Room		Item		Quantity				
	Main building		Toilet (not currently a toilet) G02		No suspect materials found		0				
	Sample No (S,SP,P,As)		Product Type		Surface Treatment		Condition		Accessibility		
	Visual (P)		N/A		N/A		N/A		N/A		
	Material Risk Score										
	N/A										
	Recommended action		No further action required								
	Surveyor comments		N/A

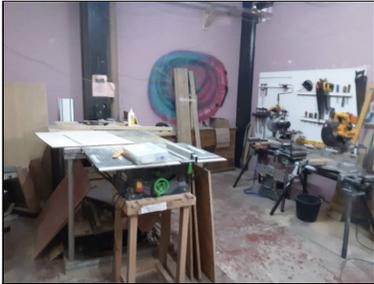
<b>Survey Date:</b>	<b>Lead Surveyor</b>	<b>Survey Type</b>	<b>Floor</b>	<b>Analysis</b>	
	26 Nov 2019 to 27 Nov 2019	Richard Watson	Management Survey with part Refurbishment/Demolition	Ground Floor	No asbestos detected	
	<b>Building</b>	<b>Room</b>	<b>Item</b>	<b>Quantity</b>		
	Main building	Woody dusty G03	No suspect materials found	0		
	<b>Sample No (S,SP,P,As)</b>	<b>Product Type</b>	<b>Surface Treatment</b>	<b>Condition</b>	<b>Accessibility</b>	
	Visual (P)	N/A	N/A	N/A	N/A	
	<b>Material Risk Score</b>					
	N/A					
	<b>Recommended action</b>	No further action required				
	<b>Surveyor comments</b>	N/A

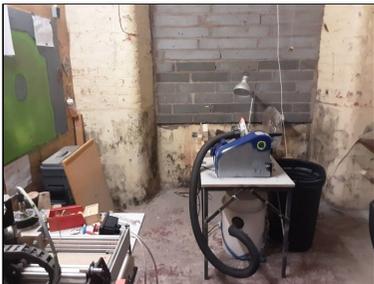
<b>Survey Date:</b>	<b>Lead Surveyor</b>	<b>Survey Type</b>	<b>Floor</b>	<b>Analysis</b>	
	26 Nov 2019 to 27 Nov 2019	Richard Watson	Management Survey with part Refurbishment/Demolition	Ground Floor	No asbestos detected	
	<b>Building</b>	<b>Room</b>	<b>Item</b>	<b>Quantity</b>		
	Main building	CNC and wood lathe G04	No suspect materials found	0		
	<b>Sample No (S,SP,P,As)</b>	<b>Product Type</b>	<b>Surface Treatment</b>	<b>Condition</b>	<b>Accessibility</b>	
	Visual (P)	N/A	N/A	N/A	N/A	
	<b>Material Risk Score</b>					
	N/A					
	<b>Recommended action</b>	No further action required				
	<b>Surveyor comments</b>	N/A

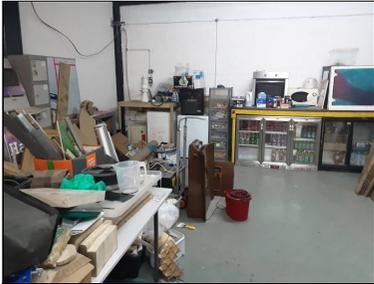
<b>Survey Date:</b>	<b>Lead Surveyor</b>	<b>Survey Type</b>	<b>Floor</b>	<b>Analysis</b>
	26 Nov 2019 to 27 Nov 2019	Richard Watson	Management Survey with part Refurbishment/Demolition	Ground Floor	No asbestos detected
	<b>Building</b>	<b>Room</b>	<b>Item</b>	<b>Quantity</b>	
	Main building	Snackspace G05	No suspect materials found	0	
	<b>Sample No (S,SP,P,As)</b>	<b>Product Type</b>	<b>Surface Treatment</b>	<b>Condition</b>	<b>Accessibility</b>
	Visual (P)	N/A	N/A	N/A	N/A
	<b>Material Risk Score</b>				
	N/A				
	<b>Recommended action</b>	No further action required			
	<b>Surveyor comments</b>	N/A

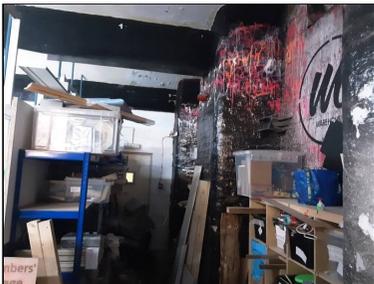
<b>Survey Date:</b>	<b>Lead Surveyor</b>	<b>Survey Type</b>	<b>Floor</b>	<b>Analysis</b>
	26 Nov 2019 to 27 Nov 2019	Richard Watson	Management Survey with part Refurbishment/Demolition	Ground Floor	No asbestos detected
	<b>Building</b>	<b>Room</b>	<b>Item</b>	<b>Quantity</b>	
	Main building	Member storage G06	No suspect materials found	0	
	<b>Sample No (S,SP,P,As)</b>	<b>Product Type</b>	<b>Surface Treatment</b>	<b>Condition</b>	<b>Accessibility</b>
	Visual (P)	N/A	N/A	N/A	N/A
	<b>Material Risk Score</b>				
	N/A				
	<b>Recommended action</b>	No further action required			
	<b>Surveyor comments</b>	N/A

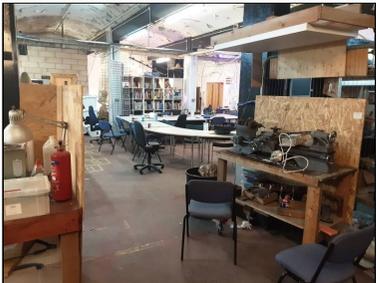
Survey Date:	Lead Surveyor	Survey Type	Floor	Analysis
	26 Nov 2019 to 27 Nov 2019	Richard Watson	Management Survey with part Refurbishment/Demolition	Ground Floor	No asbestos detected
	Building	Room	Item	Quantity	
	Main building	Main area G07	No suspect materials found	0	
	Sample No (S,SP,P,As)	Product Type	Surface Treatment	Condition	Accessibility
	Visual (P)	N/A	N/A	N/A	N/A
	Material Risk Score				
	N/A				
Recommended action	No further action required				
Surveyor comments	N/A

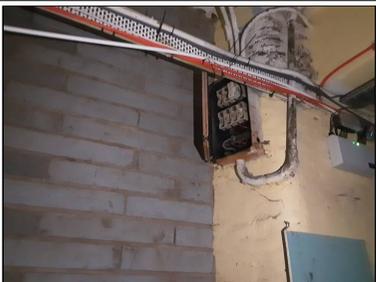
Survey Date:	Lead Surveyor	Survey Type	Floor	Analysis
	26 Nov 2019 to 27 Nov 2019	Richard Watson	Management Survey with part Refurbishment/Demolition	Ground Floor	Chrysotile (1)
	Building	Room	Item	Quantity	
	Main building	Classroom G08	Textile flashguards within fuse box	8no.	
	Sample No (S,SP,P,As)	Product Type	Surface Treatment	Condition	Accessibility
	AC001084 (S)	Asbestos Textiles/Paper (2)	Surface Sealed (1)	Low Damage (1)	Usually inaccessible or unlikely to be disturbed
	Material Risk Score				
	5				
Recommended action	A - Urgent Removal				
Surveyor comments	N/A

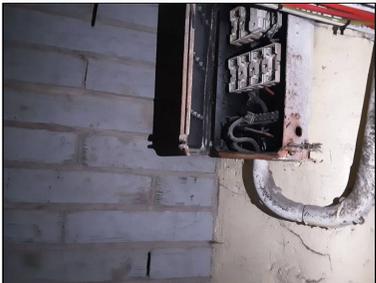
<b>Survey Date:</b>	<b>Lead Surveyor</b>	<b>Survey Type</b>	<b>Floor</b>	<b>Analysis</b>
	26 Nov 2019 to 27 Nov 2019	Richard Watson	Management Survey with part Refurbishment/Demolition	Ground Floor	Chrysotile (1)
	<b>Building</b>	<b>Room</b>	<b>Item</b>	<b>Quantity</b>	
	Main building	Classroom G08	Presumed asbestos containing electrical cables	11m	
	<b>Sample No (S,SP,P,As)</b>	<b>Product Type</b>	<b>Surface Treatment</b>	<b>Condition</b>	<b>Accessibility</b>
	Visual (P)	Asbestos Textiles/Paper (2)	Surface Sealed (1)	Low Damage (1)	Usually inaccessible or unlikely to be disturbed
	<b>Material Risk Score</b>				
5					
<b>Recommended action</b>	A - Urgent Removal				
<b>Surveyor comments</b>	Cannot sample as many still be live. presumed also within trunking within the room

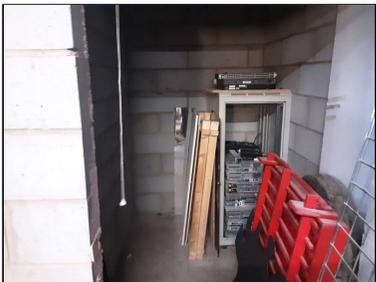
<b>Survey Date:</b>	<b>Lead Surveyor</b>	<b>Survey Type</b>	<b>Floor</b>	<b>Analysis</b>
	26 Nov 2019 to 27 Nov 2019	Richard Watson	Management Survey with part Refurbishment/Demolition	Ground Floor	No asbestos detected
	<b>Building</b>	<b>Room</b>	<b>Item</b>	<b>Quantity</b>	
	Main building	Large projects G09	No suspect materials found	0	
	<b>Sample No (S,SP,P,As)</b>	<b>Product Type</b>	<b>Surface Treatment</b>	<b>Condition</b>	<b>Accessibility</b>
	Visual (P)	N/A	N/A	N/A	N/A
	<b>Material Risk Score</b>				
N/A					
<b>Recommended action</b>	No further action required				
<b>Surveyor comments</b>	N/A

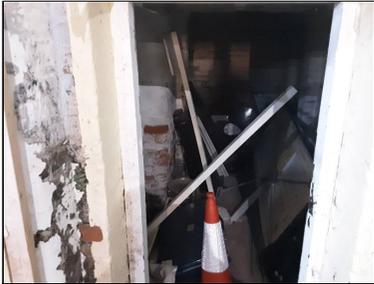
<b>Survey Date:</b>	<b>Lead Surveyor</b>	<b>Survey Type</b>	<b>Floor</b>	<b>Analysis</b>	
	26 Nov 2019 to 27 Nov 2019	Richard Watson	Management Survey with part Refurbishment/Demolition	Ground Floor	No asbestos detected	
	<b>Building</b>	<b>Room</b>	<b>Item</b>	<b>Quantity</b>		
	Main building	Photo cave G10	No suspect materials found	0		
	<b>Sample No (S,SP,P,As)</b>	<b>Product Type</b>	<b>Surface Treatment</b>	<b>Condition</b>	<b>Accessibility</b>	
	Visual (P)	N/A	N/A	N/A	N/A	
	<b>Material Risk Score</b>					
	N/A					
	<b>Recommended action</b>	No further action required				
	<b>Surveyor comments</b>	N/A

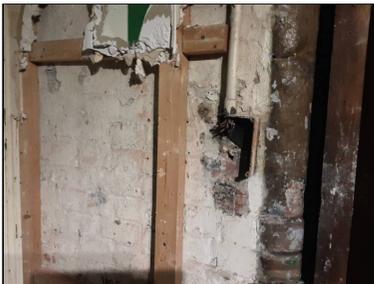
<b>Survey Date:</b>	<b>Lead Surveyor</b>	<b>Survey Type</b>	<b>Floor</b>	<b>Analysis</b>	
	26 Nov 2019 to 27 Nov 2019	Richard Watson	Management Survey with part Refurbishment/Demolition	Ground Floor	No Asbestos Detected	
	<b>Building</b>	<b>Room</b>	<b>Item</b>	<b>Quantity</b>		
	Main building	Green room G11	Textile electrical cables	11m		
	<b>Sample No (S,SP,P,As)</b>	<b>Product Type</b>	<b>Surface Treatment</b>	<b>Condition</b>	<b>Accessibility</b>	
	AC001085 (S)	N/A	N/A	N/A	N/A	
	<b>Material Risk Score</b>					
	N/A					
	<b>Recommended action</b>	No further action required				
	<b>Surveyor comments</b>	redundant old electrics, all old electrics found throughout the building should be presumed to be the same if visually similar

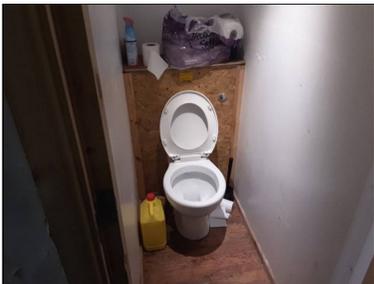
Survey Date:	Lead Surveyor	Survey Type	Floor	Analysis
	26 Nov 2019 to 27 Nov 2019	Richard Watson	Management Survey with part Refurbishment/Demolition	Ground Floor	No asbestos detected
	Building	Room	Item	Quantity	
	Main building	Spider bog G12	No suspect materials found	0	
	Sample No (S,SP,P,As)	Product Type	Surface Treatment	Condition	Accessibility
	Visual (P)	N/A	N/A	N/A	N/A
	Material Risk Score				
	N/A				
Recommended action	No further action required				
Surveyor comments	N/A

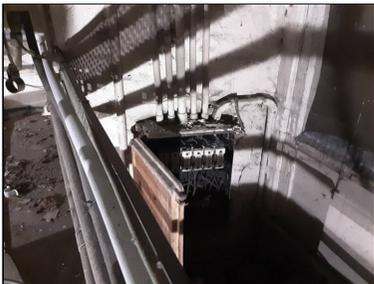
Survey Date:	Lead Surveyor	Survey Type	Floor	Analysis
	26 Nov 2019 to 27 Nov 2019	Richard Watson	Management Survey with part Refurbishment/Demolition	Ground Floor	Chrysotile (1)
	Building	Room	Item	Quantity	
	Main building	Ceiling space loft G13	Presumed asbestos containing electrical cables	1m	
	Sample No (S,SP,P,As)	Product Type	Surface Treatment	Condition	Accessibility
	Visual (P)	Asbestos Textiles/Paper (2)	Surface Sealed (1)	Low Damage (1)	Usually inaccessible or unlikely to be disturbed
	Material Risk Score				
	5				
Recommended action	A - Urgent Removal				
Surveyor comments	Cannot sample as many still be live. presumed also within trunking within the room

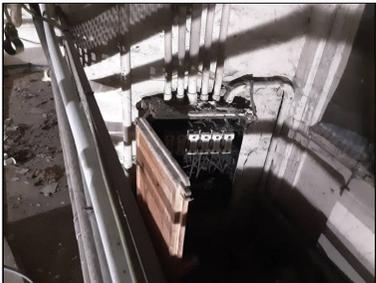
<b>Survey Date:</b>	<b>Lead Surveyor</b>	<b>Survey Type</b>	<b>Floor</b>	<b>Analysis</b>
	26 Nov 2019 to 27 Nov 2019	Richard Watson	Management Survey with part Refurbishment/Demolition	Ground Floor	Chrysotile (1)
	<b>Building</b>	<b>Room</b>	<b>Item</b>	<b>Quantity</b>	
	Main building	Ceiling space loft G13	Textile flashguards within fuse box	6no.	
	<b>Sample No (S,SP,P,As)</b>	<b>Product Type</b>	<b>Surface Treatment</b>	<b>Condition</b>	<b>Accessibility</b>
	As AC001084 (SP)	Asbestos Textiles/Paper (2)	Surface Sealed (1)	Low Damage (1)	Usually inaccessible or unlikely to be disturbed
	<b>Material Risk Score</b>				
5					
<b>Recommended action</b>	A - Urgent Removal				
<b>Surveyor comments</b>	N/A

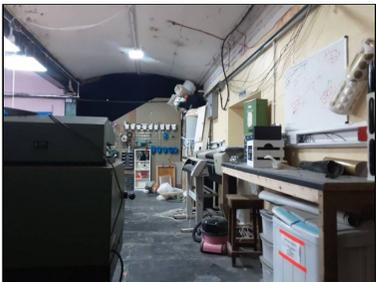
<b>Survey Date:</b>	<b>Lead Surveyor</b>	<b>Survey Type</b>	<b>Floor</b>	<b>Analysis</b>
	26 Nov 2019 to 27 Nov 2019	Richard Watson	Management Survey with part Refurbishment/Demolition	Ground Floor	No asbestos detected
	<b>Building</b>	<b>Room</b>	<b>Item</b>	<b>Quantity</b>	
	Main building	Visual arts G14	No suspect materials found	0	
	<b>Sample No (S,SP,P,As)</b>	<b>Product Type</b>	<b>Surface Treatment</b>	<b>Condition</b>	<b>Accessibility</b>
	Visual (P)	N/A	N/A	N/A	N/A
	<b>Material Risk Score</b>				
N/A					
<b>Recommended action</b>	No further action required				
<b>Surveyor comments</b>	N/A

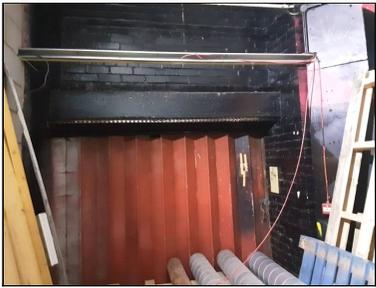
Survey Date:	Lead Surveyor	Survey Type	Floor	Analysis
	26 Nov 2019 to 27 Nov 2019	Richard Watson	Management Survey with part Refurbishment/Demolition	Ground Floor	No asbestos detected
	Building	Room	Item	Quantity	
	Main building	Grinding area G15	No suspect materials found	0	
	Sample No (S,SP,P,As)	Product Type	Surface Treatment	Condition	Accessibility
	Visual (P)	N/A	N/A	N/A	N/A
	Material Risk Score				
	N/A				
	Recommended action	No further action required			
	Surveyor comments	N/A

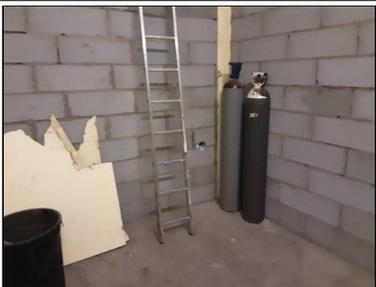
Survey Date:	Lead Surveyor	Survey Type	Floor	Analysis
	26 Nov 2019 to 27 Nov 2019	Richard Watson	Management Survey with part Refurbishment/Demolition	Ground Floor	No asbestos detected
	Building	Room	Item	Quantity	
	Main building	Welding G16	No suspect materials found	0	
	Sample No (S,SP,P,As)	Product Type	Surface Treatment	Condition	Accessibility
	Visual (P)	N/A	N/A	N/A	N/A
	Material Risk Score				
	N/A				
	Recommended action	No further action required			
	Surveyor comments	N/A
