Lead Surveyor: John Shirley
Assistant Surveyor(s): N/A
Date(s) of Survey: 14/02/2018
Report Reference: CH/18/2/484/LW
Date Report Issued: 13th March 2018
Purpose of Survey:

Report on Survey of Asbestos Materials At

**Wellington House
Pollard Street East
Manchester
M40 7FS**

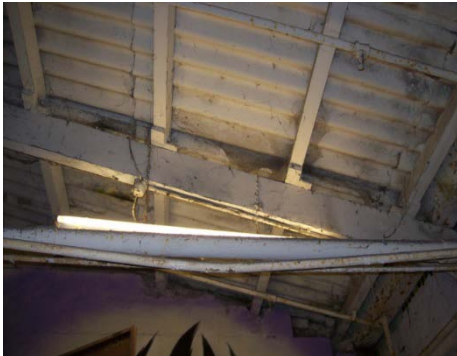
| Location (Refer to Asbestos Register - Section 5.1) | ACM Type | Condition | Recommendation |
|--|---|---|---|
| G.01 Ground Floor - Goods Lift Lobby Roof | Cement Materials | Fair | Manage & Review OR Remove & Dispose Refer to Section 5.2 |

Sample No: 18/2/B/14/JPS1
G.01 Ground Floor
Goods Lift Lobby
Corrugated Cement Roof

- Location:** G.01 Ground Floor Goods Lift Lobby Roof (Painted)
- Items & Content:** Cement Materials Containing Chrysotile (White) Asbestos
Sample No: 18/2/B/14/JPS1
- Recommendation:** These materials are in a fair condition and sealed with paint and are unlikely to generate airborne asbestos fibre during normal occupation provided they remain undisturbed.

We recommend that these materials are labelled for identification purposes, managed and periodically re-inspected as required by The Control of Asbestos Regulations 2012.

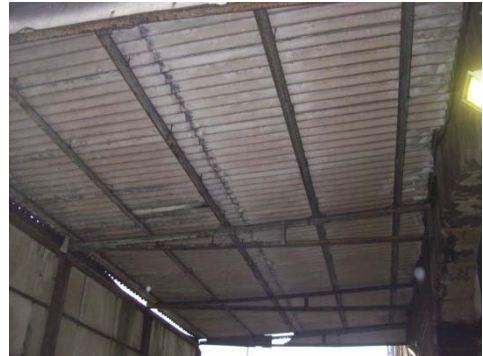
| Location (Refer to Asbestos Register - Section 5.1) | ACM Type | Condition | Recommendation |
|--|---|---|---|
| Ex.1 Ground Floor External Canopy Loading Area Roof | Cement Materials | Fair | Manage & Review OR Remove & Dispose Refer to Section 5.2 |

As Sample No: 18/2/B/14/JPS1
Ex.1 Ground Floor
External Canopy Loading Area
Corrugated Cement Roof

- Location:** Ex 1 Ground Floor External Canopy to Loading Area Rear Wall/Up-stands and Roof
- Items & Content:** Cement Materials Containing Chrysotile (White) Asbestos
Sample No: 18/2/B/14/JPS2 and As JPS1
- Recommendation:** These materials are in a fair condition and are unlikely to generate airborne asbestos fibre during normal occupation provided they remain undisturbed.

We recommend that these materials are labelled for identification purposes, managed and periodically re-inspected as required by The Control of Asbestos Regulations 2012.

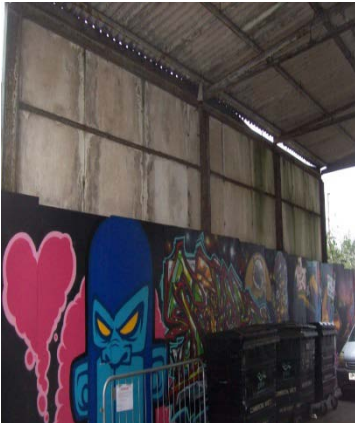
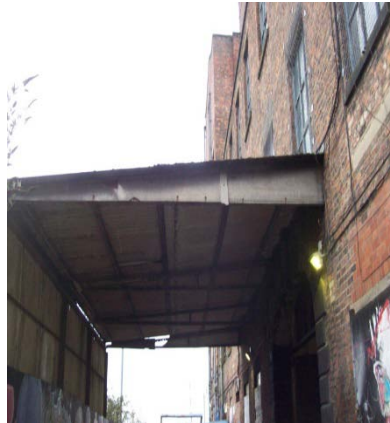
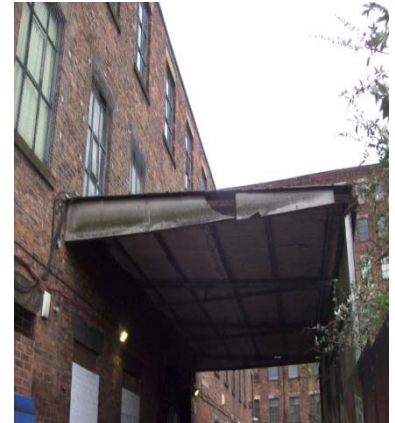
| Location (Refer to Asbestos Register - Section 5.1) | ACM Type | Condition | Recommendation |
|--|---|---|---|
| Ex 1 Ground Floor External Canopy to Loading Area Rear Wall /Up-stands | Cement Materials | Fair | Manage & Review OR Remove & Dispose Refer to Section 5.2 |

Sample No: 18/2/B/14/JPS2
Ex.1 Ground Floor
External Canopy Loading Area
Rear Wall/Up-stands
Cement Sheets

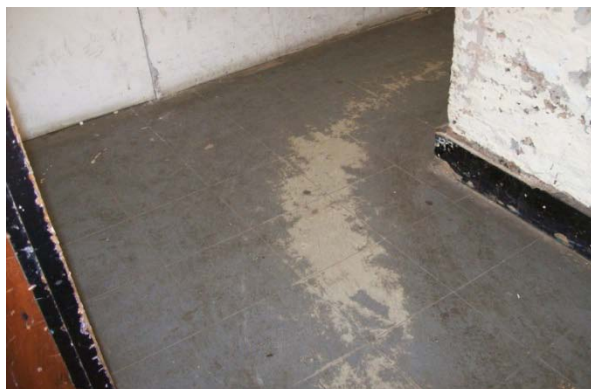
| Location (Refer to Asbestos Register - Section 5.1) | ACM Type | Condition | Recommendation |
|--|---|---|---|
| G.05 Ground Floor Circulation Area / Stairwell | Vinyl Floor Tiles and Bitumen Adhesive | Fair | Manage & Review OR Remove & Dispose Refer to Section 5.2 |

Sample No: 18/2/B/14/JPS4
G.05 Ground Floor Circulation Area/Stairwell
Vinyl Floor Tiles and Bitumen Adhesive

- Location:** G.05 – Ground Floor Circulation Area/Stairwell
1.01 First Floor Circ Area/Stairwell
2.01 2nd Floor Circ Area/Stairwell
- Items & Content:** Vinyl Floor Tiles and Bitumen Adhesive Containing Chrysotile (White) Asbestos
Sample No: 18/2/B/14/JPS4
- Recommendation:** These materials are in a fair condition and are unlikely to generate airborne asbestos fibre during normal occupation provided they remain undisturbed.

We recommend that these materials are labelled for identification purposes, managed and periodically re-inspected as required by The Control of Asbestos Regulations 2012.

They should remain undisturbed and any future Maintenance, remedial or removal works undertaken by suitably trained personnel only. Work should be under the guidance of a safe working procedure and in accordance with the requirements of **The Control of Asbestos Regulations 2012 and The Hazardous Waste Regulations (England and Wales) (2009 Amendment)**.

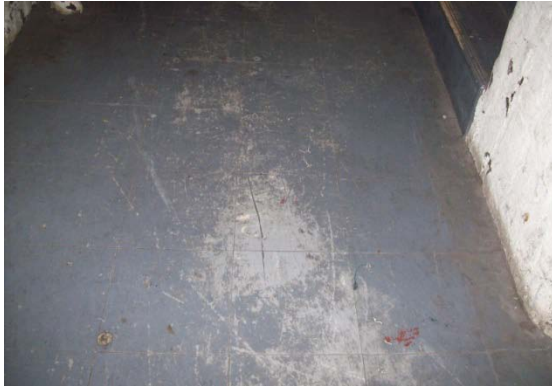
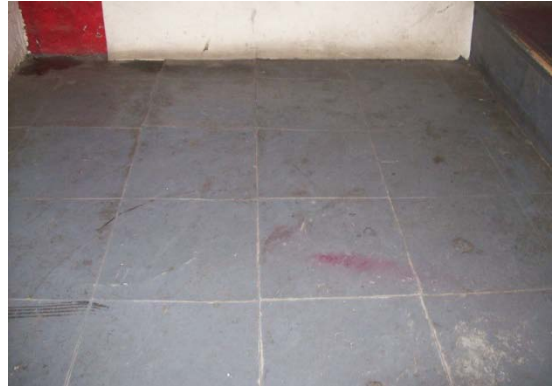
| Location (Refer to Asbestos Register - Section 5.1) | ACM Type | Condition | Recommendation |
|--|---|---|---|
| 1.01 First Floor Circ Area / Stairwell | Vinyl Floor Tiles and Bitumen Adhesive | Fair | Manage & Review OR Remove & Dispose Refer to Section 5.2 |

As Sample No: 18/2/B/14/JPS4
1.01 First Floor Circulation Area/Stairwell
Vinyl Floor Tiles and Bitumen Adhesive

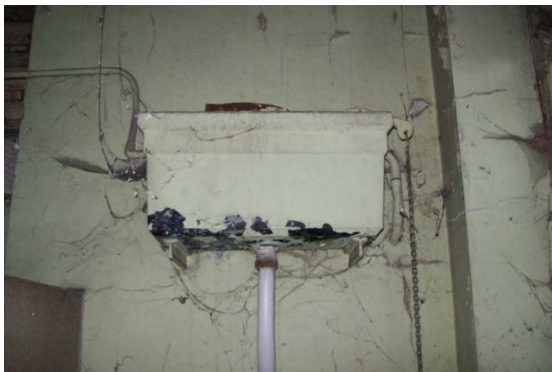
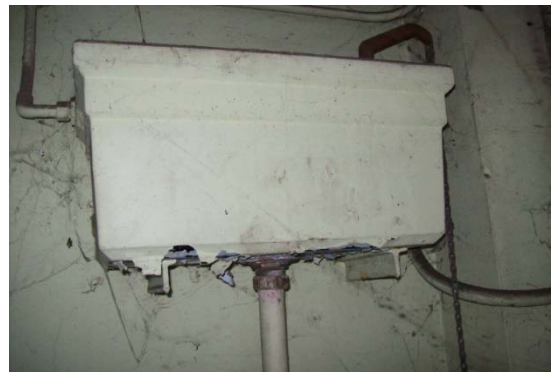
| Location (Refer to Asbestos Register - Section 5.1) | ACM Type | Condition | Recommendation |
|--|---|---|---|
| 1.07 First Floor Redundant Toilet Cisterns | Thermoplastic | Good | Manage & Review OR Remove & Dispose Refer to Section 5.2 |

Sample No: 18/2/B/14/JPS8
1.07 First Floor Redundant Toilet
Thermoplastic Cistern

- Location:** 1.07 First Floor Redundant Toilet
Thermoplastic Cisterns
- Items & Content:** Thermoplastic Containing Crocidolite (Blue) Asbestos
Sample No: 18/2/B/14/JPS8
- Recommendation:** These materials are in good condition and are unlikely to generate airborne asbestos fibre during normal occupation provided they remain undisturbed.

We recommend that these materials are labelled for identification purposes, managed and periodically re-inspected as required by The Control of Asbestos Regulations 2012.

They should remain undisturbed and any future Maintenance, remedial or removal works undertaken by suitably trained personnel only. Work should be under the guidance of a safe working procedure and in accordance with the requirements of **The Control of Asbestos Regulations 2012 and The Hazardous Waste Regulations (England and Wales) (2009 Amendment)**.

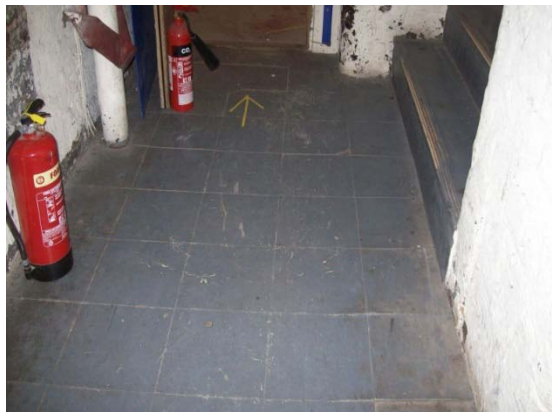
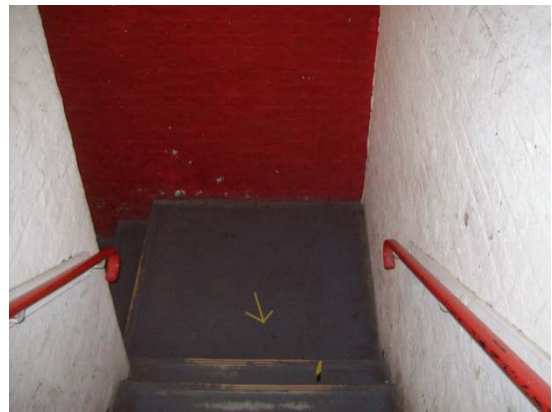
| Location (Refer to Asbestos Register - Section 5.1) | ACM Type | Condition | Recommendation |
|--|---|---|---|
| 2.01 2nd Floor Circ Area / Stairwell | Vinyl Floor Tiles and Bitumen Adhesive | Fair | Manage & Review OR Remove & Dispose Refer to Section 5.2 |

As Sample No: 18/2/B/14/JPS4
2.01 2nd Floor Circulation Area/Stairwell
Vinyl Floor Tiles and Bitumen Adhesive

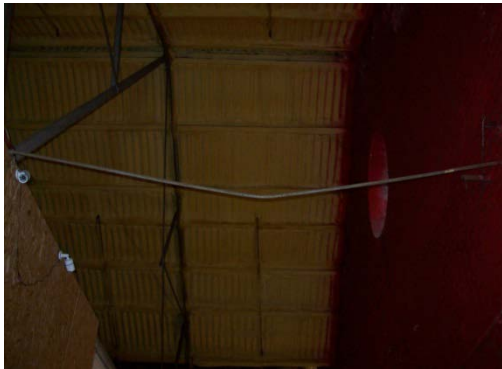
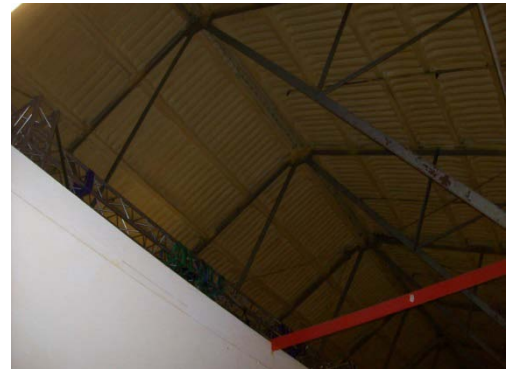
| Location (Refer to Asbestos Register - Section 5.1) | ACM Type | Condition | Recommendation |
|--|---|---|--|
| 4.01 4 th Floor Goods Lift Lobby 4.02 Corridor to Units 40-47 - Corrugated Cement Roof Sheets Covered (Encapsulated) with a Spray Foam Insulation | Cement Materials (Encapsulated) | Good | Manage & Review Refer to Section 5.2 |

Sample No: 18/2/B/14/JPS13
4.01 4th Floor Goods Lift Lobby
Spray Foam Insulation Covered Corrugated Cement Roof Sheets

- Location:** 4.01 4th Floor Goods Lift Lobby and 4.02 Corridor to Units 40-47
Corrugated Asbestos Cement Roof Sheets covered with Spray Foam Insulation
(Encapsulated / Sealed)
- Items & Content:** Cement Materials Containing Chrysotile (White) Asbestos
Sample No: 18/2/B/14/JPS13
- Recommendation:** These materials are in good well sealed condition (Covered with Spray Foam Insulation) condition and are unlikely to generate airborne asbestos fibre during normal occupation provided they remain undisturbed.

We recommend that these materials are labelled for identification purposes, managed and periodically re-inspected as required by The Control of Asbestos Regulations 2012.

These materials must remain undisturbed. Any future remedial or removal works should be undertaken by suitably trained and equipped personnel. Work is to be under the guidance of a safe working procedure and in accordance with the requirements of **The Control of Asbestos Regulations 2012 and The Hazardous Waste (England and Wales) (Amendment) Regulations 2009.**

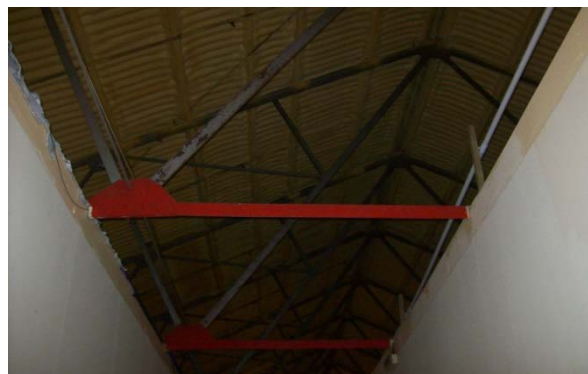
As Sample No: 18/2/B/14/JPS13
4.02 Corridor to Units 40-47
Spray Foam Insulation Covered Corrugated Cement Roof Sheets

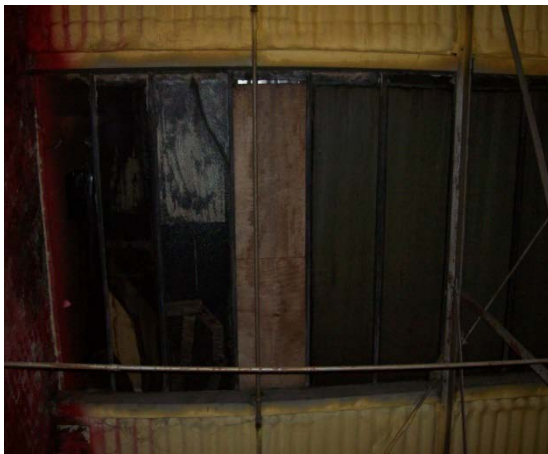
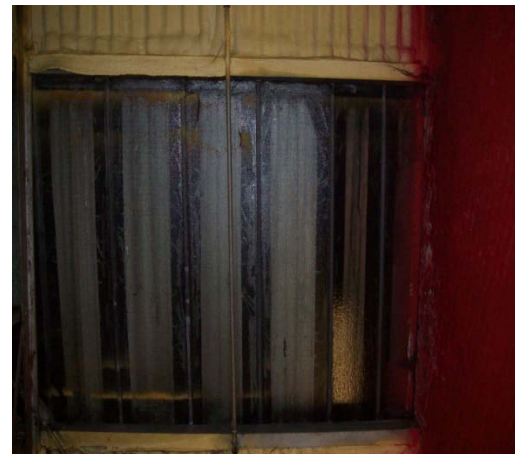
| Location (Refer to Asbestos Register - Section 5.1) | ACM Type | Condition | Recommendation |
|--|---|---|---|
| 4.01 4 th Floor Goods Lift Lobby Northern roof lights (Presumed No Safe Access) | Presumed woven rope to glazing bars | Good | Manage & Review Refer to Section 5.2 |

4.01 4th Floor Goods Lift Lobby
Strongly Presumed Woven Rope Seal
to Glazing Bars of Northern Roof Light
(No Safe Access)

- Location:** 4.01 4th Floor Goods Lift Lobby Northern roof lights
- Items & Content:** Presumed Woven Rope to Glazing Bars –NO SAFE ACCESS
- Recommendation:** These materials are in good condition and are unlikely to generate airborne asbestos fibre during normal occupation provided they remain undisturbed.

We recommend that these materials are labelled for identification purposes, managed and periodically re-inspected as required by The Control of Asbestos Regulations 2012.

These materials must remain undisturbed. Any future remedial or removal works should be undertaken by suitably trained and equipped personnel. Work is to be under the guidance of a safe working procedure and in accordance with the requirements of **The Control of Asbestos Regulations 2012 and The Hazardous Waste (England and Wales) (Amendment) Regulations 2009.**
